## Case Studies

## **7.2. CASE STUDY 1: INCIDENT ANALYSIS OF HYDROCARBON LEAK FROM PIPE**

## 7.3. CASE STUDY 2: INCIDENT INVESTIGATION: MISCHARGING OF SOLVENT IN A BATCH PLANT

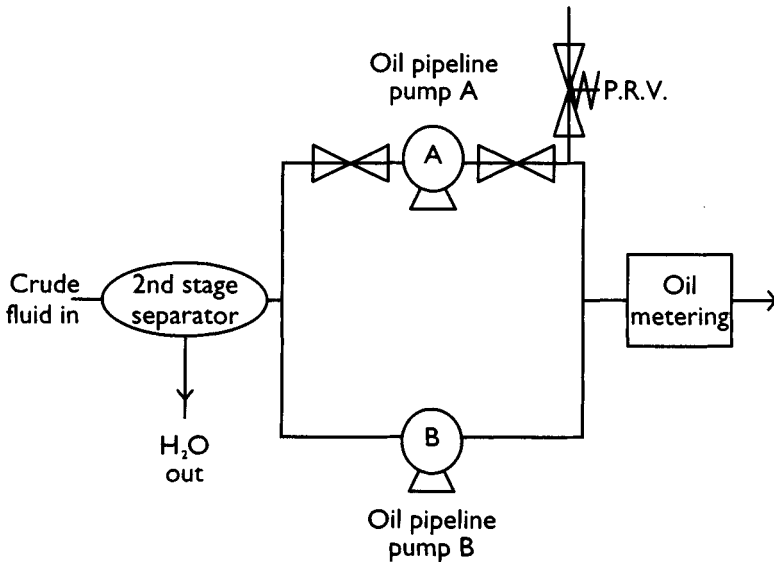
FIGURE 7.1. Simplified Process Diagram: Hydrocarbon Leak From Pipe (from Cullen, 1990).

The process involved in the incident is concerned with the separation of crude into three phases. The crude is pumped into a two stage separation process where it is divided into three phases; oil, gas, and water. The water is cleaned up and dumped to drain. The remaining mixture of oil and gas is then pumped into the main oil line where it is metered and sent on for further processing. A simplified process diagram is shown in Figure 7.1. The case study described here is centered on a flange leak in one of the oil pipeline pumps (pump A) and its associated pressure relief valve piping.

switched on to the standby pump A. Monitoring the oil level in the separator, the operator saw the level fall. Unknown to the control room operator, switching to pump A resulted in high pressure oil and gas leaking from the incorrectly fitting blank. The control room operator's monitoring of the oil level was interrupted by the gas monitoring system giving an alarm. The operator accepted the alarm but was not unduly worried, thinking it was a false alarm, as often happens after work has been done on a pump. He decided to radio the plant operator and asked him to check it out. The oil level continued to fall in the separator, and the leaking flange continued to release oil and gas into the separation building. The plant operator, responding to the control room operator's request, went to investigate the low level alarm in the separation building. While the control room operator was waiting for the operator to report back, the high gas alarm sounded. He immediately started safety shutdown procedures. It was at this point that the oil and gas mixture ignited and exploded, and the next phase of the Piper Alpha disaster began.

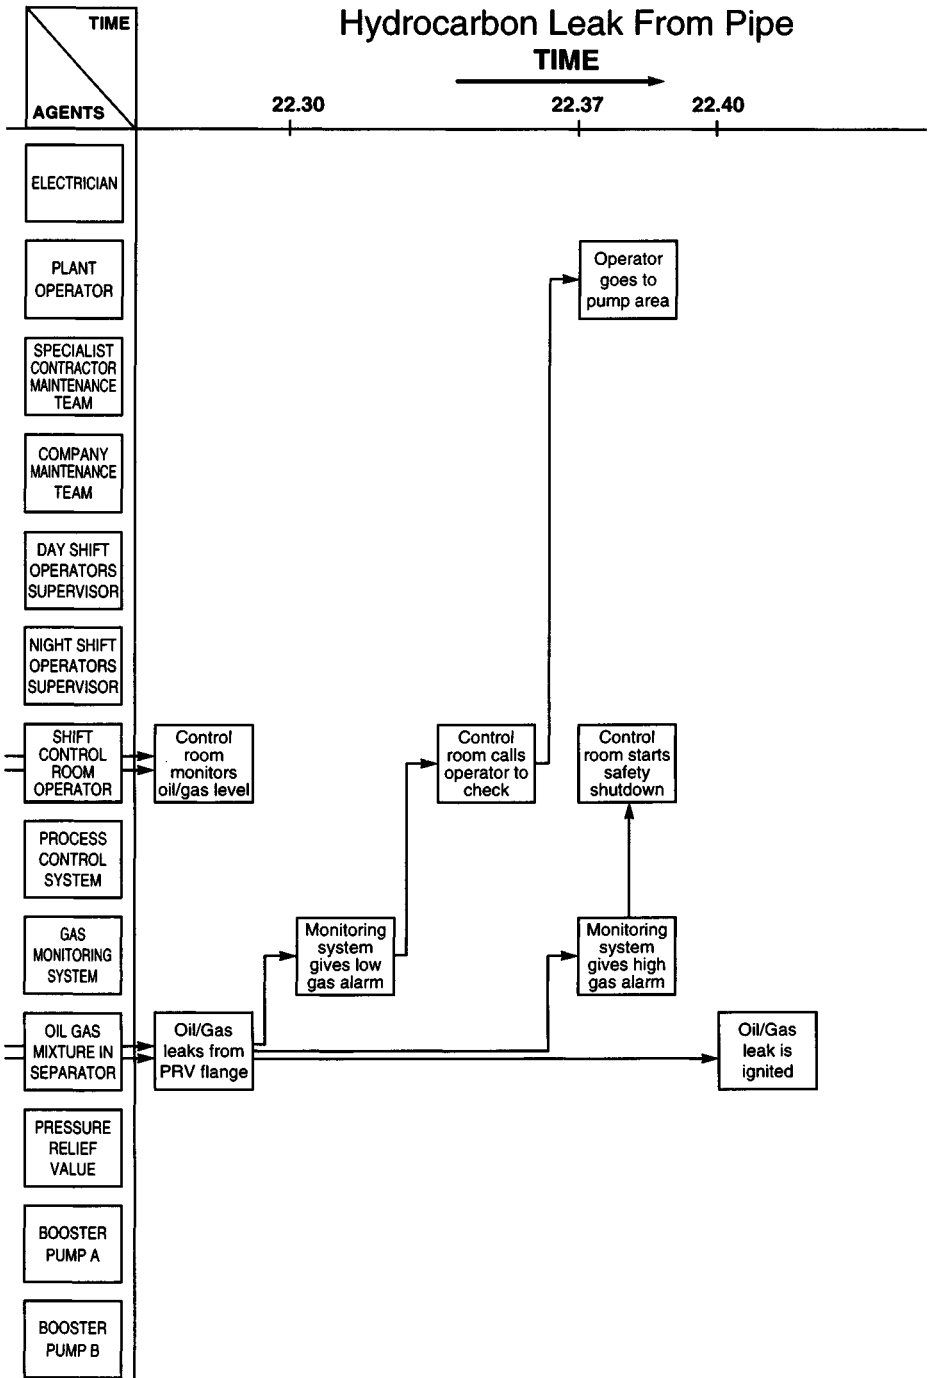
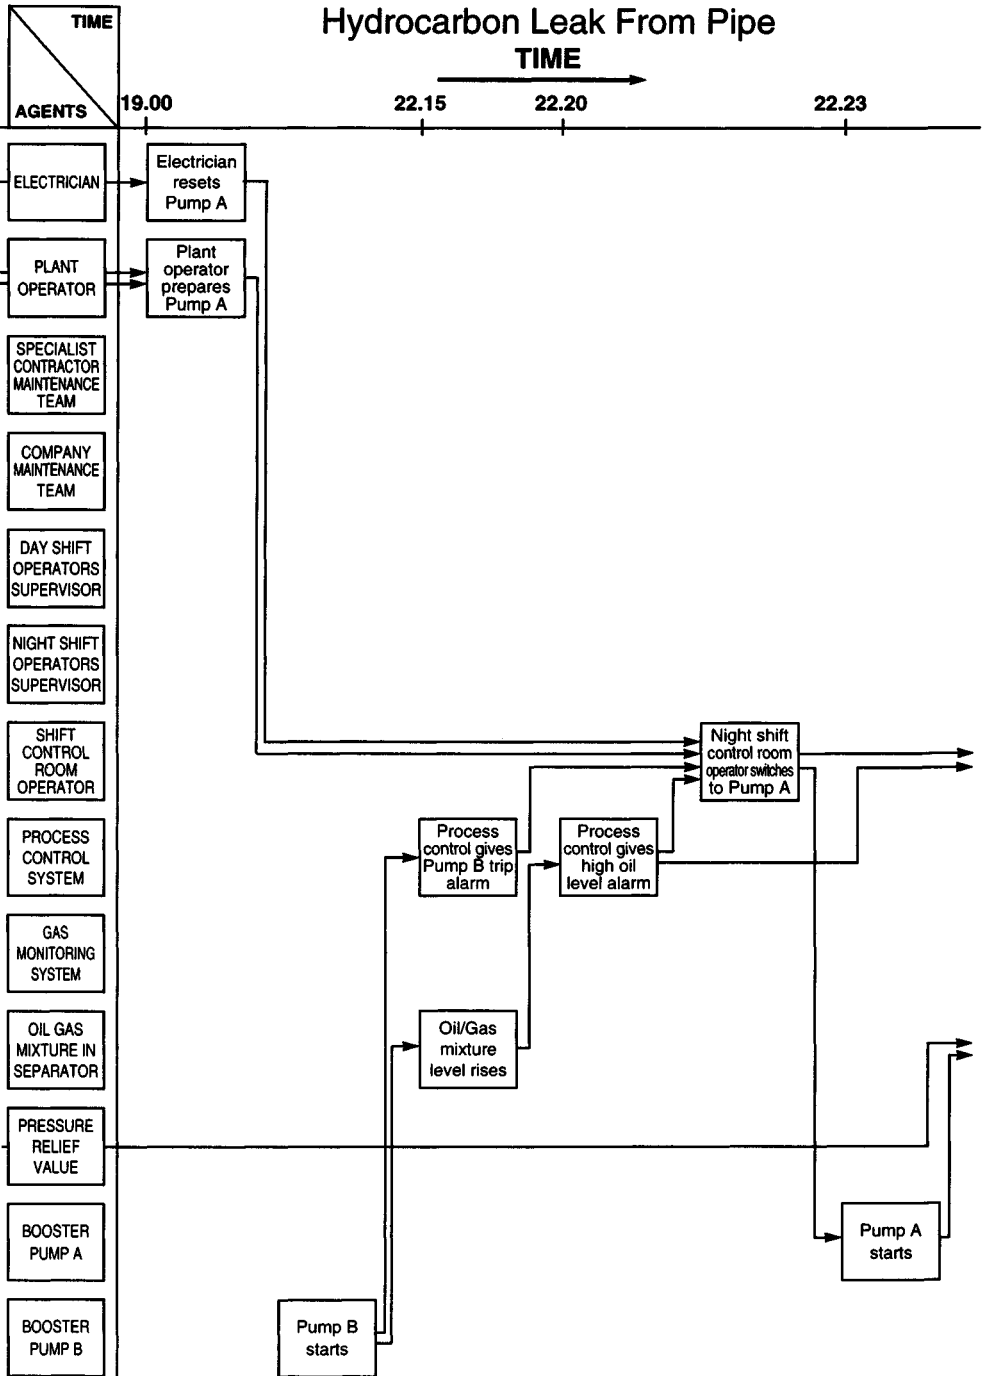
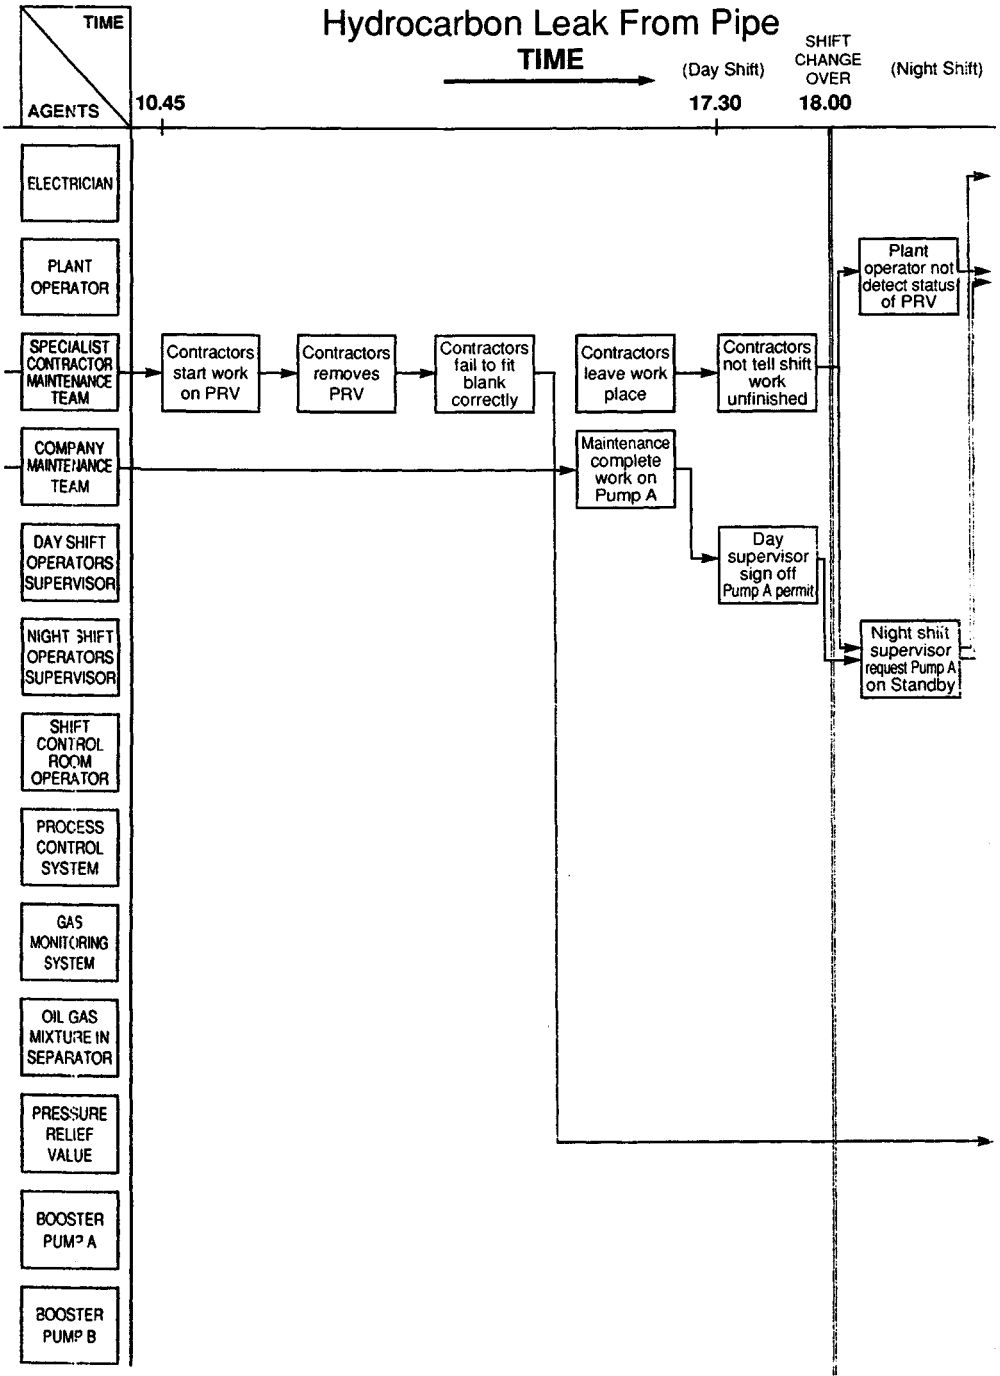
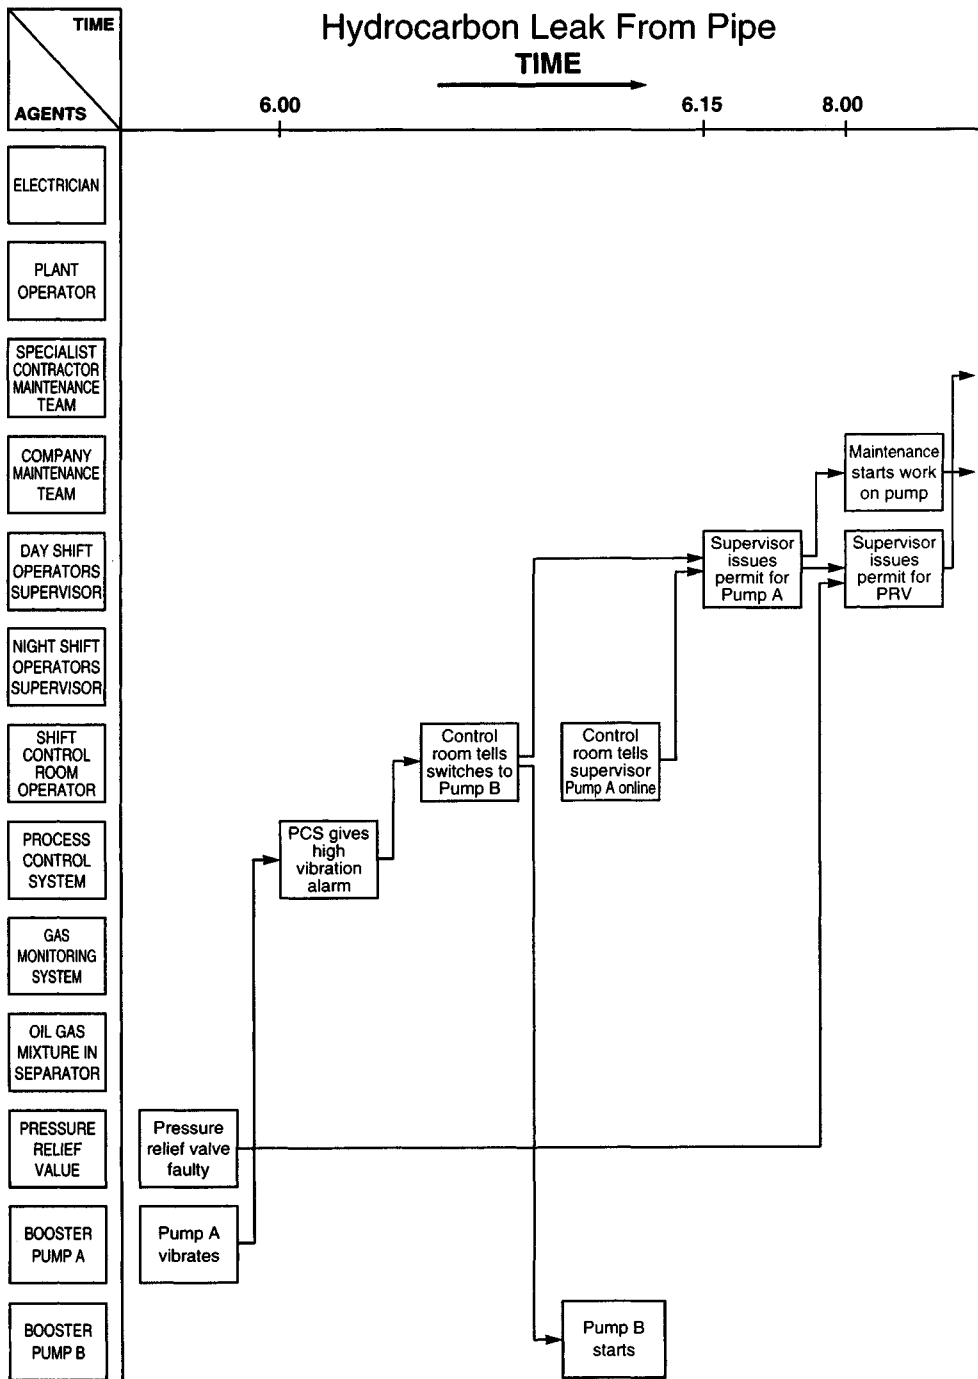
FIGURE 7.2 STEP Diagram of Hydrocarbon Leak from Pipe, Page 1 of 4.

The STEP work sheet shown in Figure 7.2 is developed during the analysis. It will obviously be simple and patchy at first, but serves as an important aid in guiding and structuring the data collection and representation. It is important to use a form of work sheet which is easy to construct and modify. Flip charts and add-on stickers are an ideal basis for the work sheet, and are also easy to change. The agents are placed on the vertical axis of the work sheet. This is the start state, the point at which the first deviation in the planned process which led to the incident is identified. In this incident this was found to be the vibrating pump A. The horizontal axis represents the time line on which events are fixed for each agent. The aim is to trace each agent's actions

As the diagram develops, a necessary and sufficient test is applied to event pairs. For example, the event involving the night shift controller switching from pump B to pump A and the tripping of pump B are necessary for the

event, but not sufficient to cause this event. The process control system gave the high oil level alarm which reduced the time window for the operator to take other action, for example, investigating the cause of the trip. However, other events were also necessary. These were the confirmations by the plant operator and electrician that pump A had been placed back on standby. If this had not happened the option to switch to pump A would not have been available. The necessary and sufficient test led to both converging arrow links, as above, and also diverging links, for example where the gas/oil leaking from the flange leads to both high and high high gas alarms and is necessary for the ignition of the leak. In this way, the relationships among events were elicited and the investigator was forced to think about causal events one at a time instead of considering the incident as a whole. The process of data collection, with its conversion to events, building block positioning and logic testing, was an iterative one and this diagram went through several revisions.

This stage involved the identification of critical actions and events in the incident process. Three critical events were identified from the STEP diagram. These were

- Failure to fit the blank correctly
- Changeover between day and night supervisor
- Contractor fails to report status of work

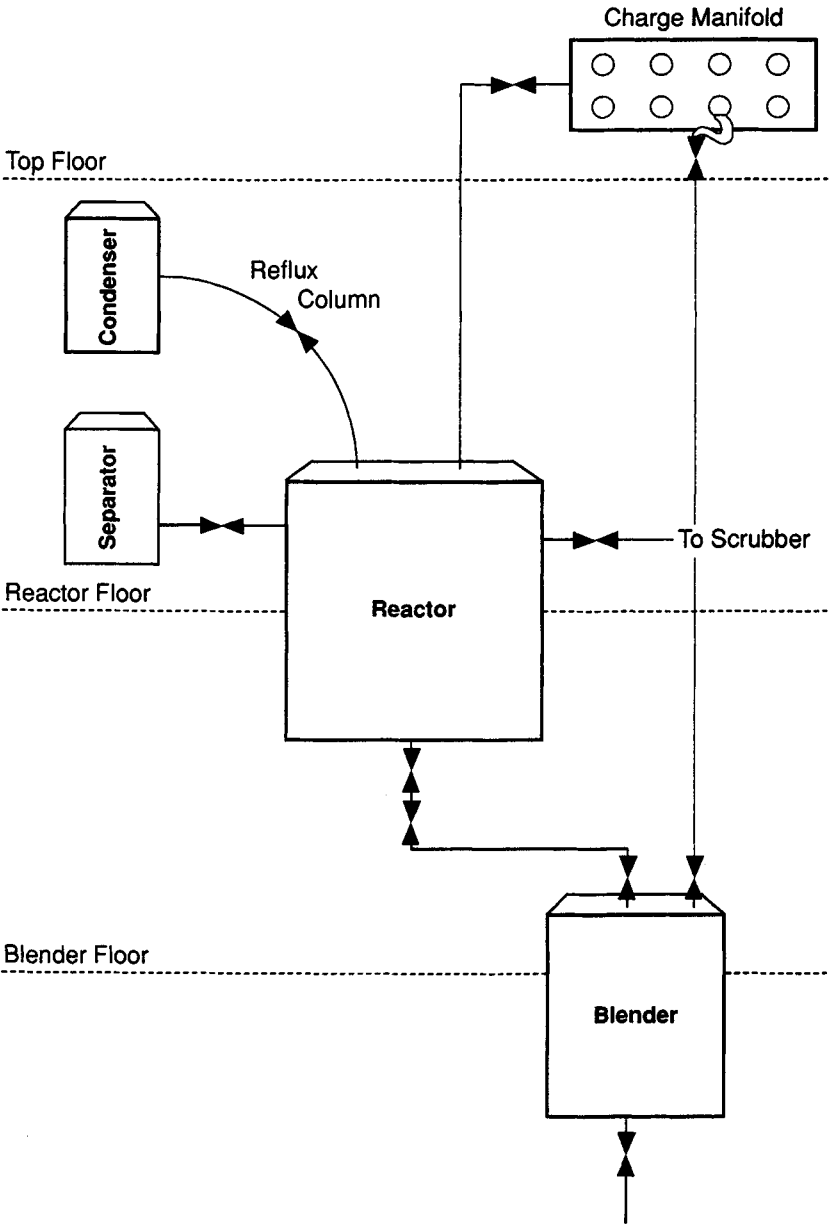
FIGURE 7.6 Simplified Schematic Plant Diagram.

The incident under consideration occurred in a batch processing plant in which batches of resins produced in various reactors are discharged into blenders to achieve the required viscosity by the addition of solvents. Solvent is charged into the blender via a valved pipeline which originates at the top floor of the building (see Figure 7.6). From the top floor the allocated worker is responsible for the pumping of solvents to the reactors or blenders via a metered solvent bank and a charging manifold.

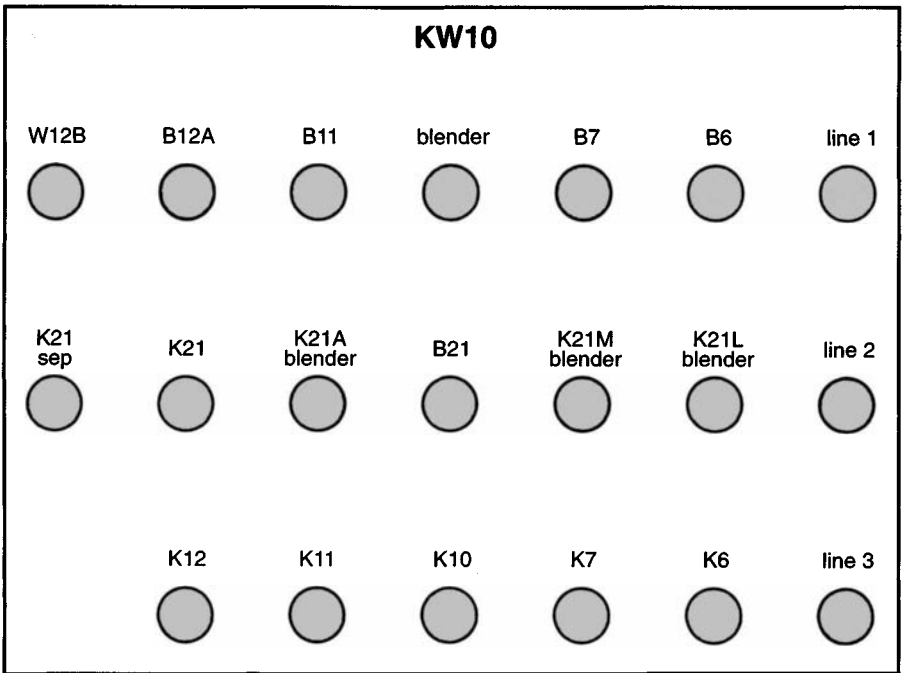
FIGURE 7.7 Charging Manifold.

The solvent bank consists of a number of metered pumps from the storage tanks which, by using flexible pipes (hoses) and quick fit couplings, the top floor man connects to the required pipeline. These pipelines are arranged in a charging manifold with each being labeled and having a valve adjacent to the coupling (see Figure 7.7).

One day, the lead operator gave verbal and written instructions, via a second worker, to the top floor man to pump solvent to 12A blender. The top floor man actually pumped the solvent to 21A blender, as a result of connecting the hose to the 21A blender pipe and not the 12A blender pipe. Consequently the solvent pumped to 21A blender was charged on top of another batch already in 21A blender. The contaminated batch had to be pumped back into a reactor where the mischarged solvent was removed by the application of vacuum.

*Evaluation level:* create a system, in accordance with ergonomic criteria, that is error tolerant and supports error recovery; redesign charging manifold (see Figure 7.7) using functional grouping corresponding to the actual layout of system.

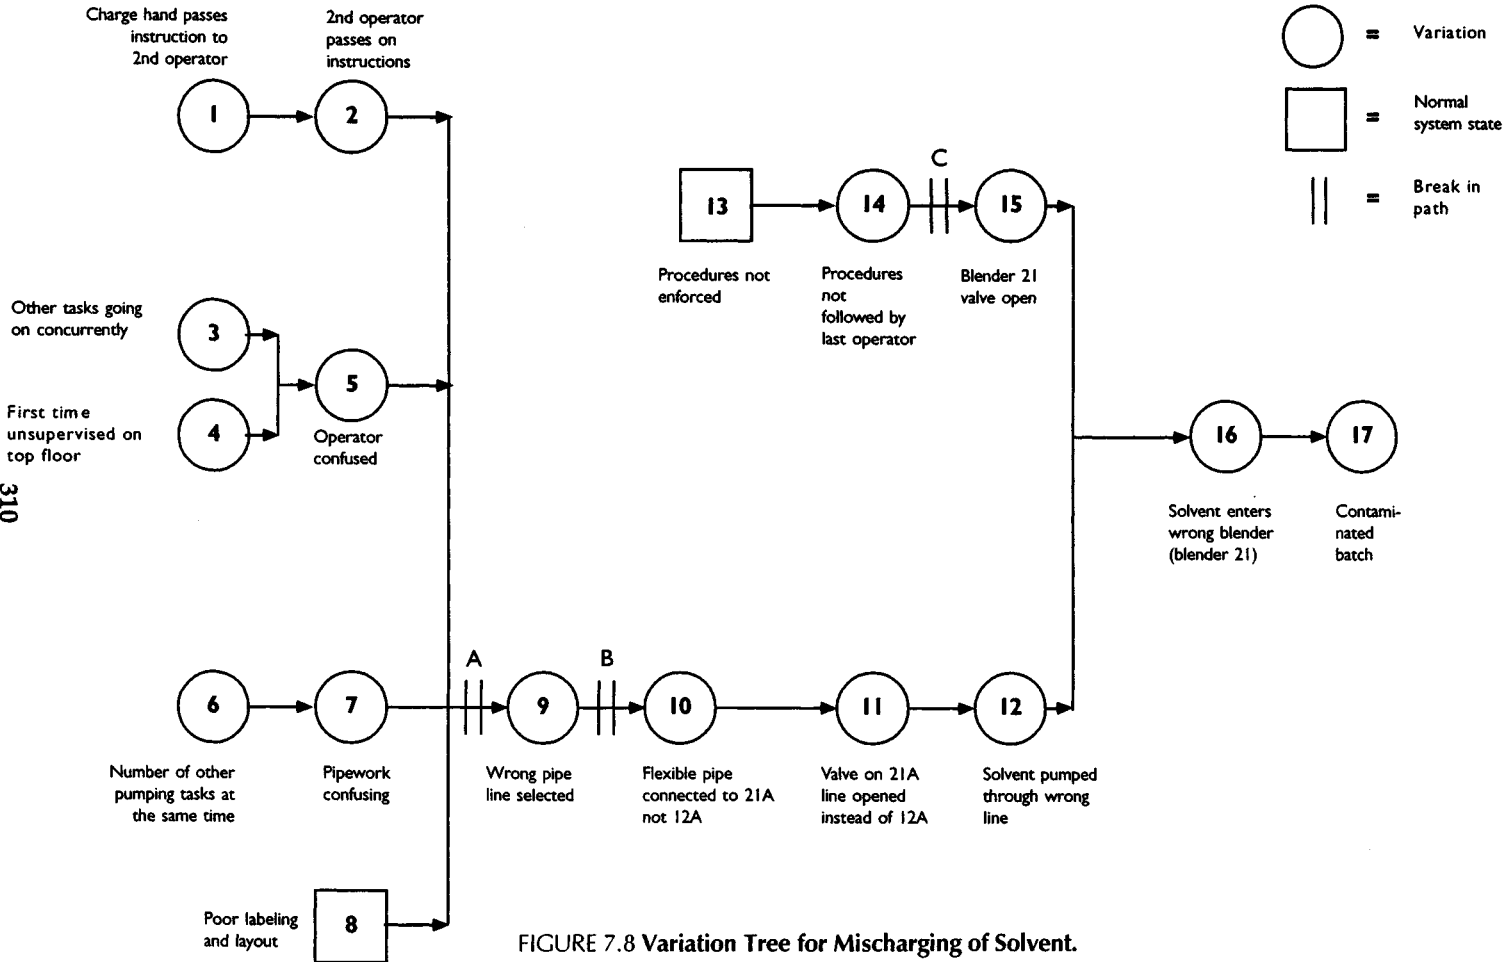
FIGURE 7.8 Variation Tree for Mischarging of Solvent.

The information gathered relating to the incident was used to identify the sequence of causes and consequences which led to the mischarge. From the resulting variation tree (see Figure 7.8) two critical points and their contributory factors can be identified.

First, the selection of the wrong pipeline was influenced by a number of factors such as poor labeling and layout. A "spaghetti" of confusing pipework was already on the charging manifold as a result of a number of concurrent

pumping tasks. Also the worker was confused and possibly stressed due to inadequate training and the number of tasks being carried out at that time. Second, the charging of the solvent into the wrong blender could still have been avoided if the blender valve had been closed, as specified in the procedures. It was found that it was standard practice to leave this valve open in order to save the staff from having to open and close the valves with each charging. Also, there was no feedback to the worker with regard to the status of the valves.

To generate error reduction strategies, the incident sequence can be altered either by **canceling the variations** (the numbered nodes in Figure 7.8) or by **breaking the path** (shown by numbered vertical lines across the path). This is achieved by considering the cognitive processing level of the operation required at each stage, using Rasmussen's stepladder model (see Chapter 2 and Figure 4.11, Chapter 4), and addressing error reduction strategies at the levels which are specified in the model. A selection of possibilities follows.

- **nodes 3, 4, 5, 6** (relate to the training and workload of the operator)  
Changes to remove some of these nodes could include:  
*Identification level:* too many jobs being done at once; limit work operator undertakes at one time.  
*Observation level:* some form of queuing system for jobs required.  
*Evaluation level:* management must outline explicit criteria for running concurrent tasks; train staff not only in normal work situations, but also in heavy work load situations; use valid training methods and provide procedures.

- **node 15**  
*Activation level:* install alarm system for indicating valve left open.  
*Observation level:* provide checklist to operators; make valve more accessible or remotely operable.  
*Interpretation level:* increase staff awareness of the consequences for safety, etc.  
*Evaluation level:* change operators' criteria for performance—enforce meaningful procedures—address work conditions and social content. Also it is necessary to change management's perception of the need for supervision and the importance of solvent charging. Obviously it is a failure of supervision to be unaware or to tolerate that valves were not reset after use.  
*Execution Level:* Enhance accessibility of valve or introduce remote operation.

- **nodes 5, 7, and 8** (relate to the design and ergonomic considerations of the situation). Designers need to acknowledge and address human-machine interface issues:

*Observation and identification levels:* ensure labeling is clear, consistent, and easily distinguished using color-coded pipework; improve work environment (e.g., lighting and general housekeeping).

- At A, develop a method for facilitating selection of correct pipework such as a light system activated by the person giving the instruction, or a key system that requires a key from a specific valve to operate the coupling on the pipeline related to this valve
- At B, develop an alarm system indicating when a wrong connection is made
- At C, change procedures to reflect actual performance, provide checklists, alter worker's perception of the importance and consequences of leaving valves open, and improve the supervision of procedures. Some form of lock system would be of benefit

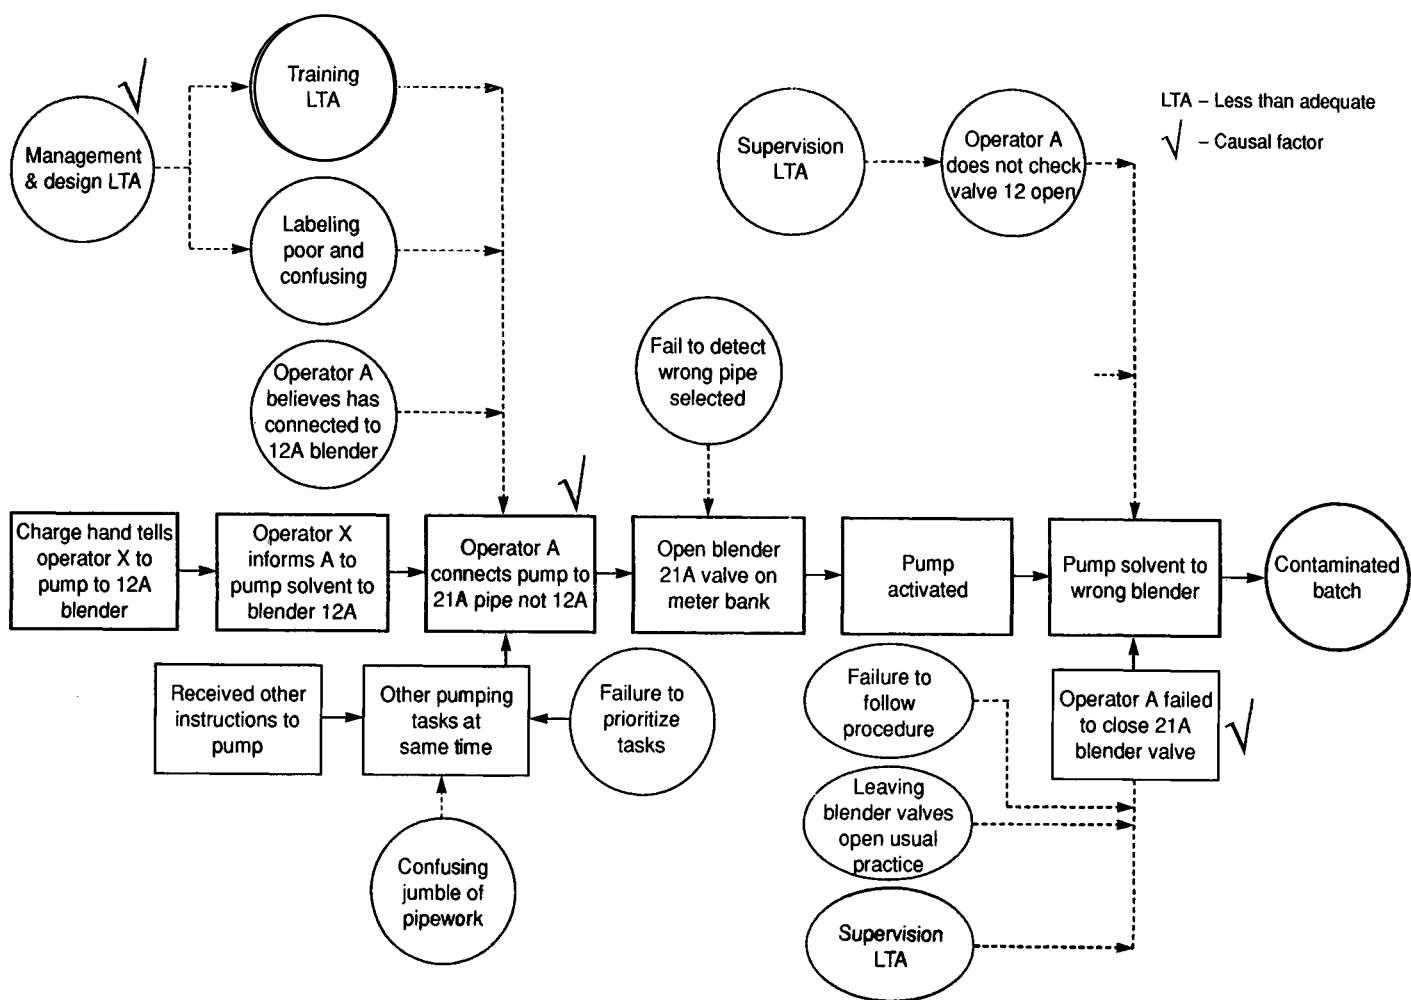
FIGURE 7.9. Events and Causal Factors Chart.

The events and causal factors chart for this incident is shown in Figure 7.9. The primary sequence of events is shown horizontally in bold boxes. Secondary events are shown in the other boxes, and conditions are in ovals. From the diagram three causal factors were identified and carried forward to the Root Cause Coding to establish the root causes of the causal factors.

- **Root cause 1.** Scheduling less than adequate; the excessive number of jobs required of the worker had a detrimental effect on his performance.
- **Root cause 2.** Incomplete training; the incident occurred during the worker's first time alone on the top floor. Training had been given but only in low task demand situations.
- **Root cause 3.** Corrective action not yet implemented; management had been aware of problems with the vessel and solvent banks but had done nothing about it.

- **Root causes 4 and 5.** Human-machine interface less than adequate. The labeling of the pipe was poor and confusing, the general ergonomics of the work situation was poor.
- **Root cause 6.** The system was not error tolerant. The error made was not detectable.
- **Root cause 7.** Personal performance. Attention may have been less than adequate.

- **Root causes 1, 2, and 3.** Procedures were not followed. Procedures were not written down and in practice were inconvenient to use. No audit was made to verify the usability of the procedures.
- **Root causes 4 and 5.** There had been no supervision of the worker who should close the blender valves after completion of the job. No audit was made to verify that valves were routinely closed.
- **Root causes 6, 7, and 8.** Human factors aspects were inadequately addressed. Specifically, ergonomics of the plant was poor, there were differences in layout among different areas and the labeling was poor.
- **Root causes 9 and 10.** There may have been a communications problem in telling the worker to close the valve or the personal performance of the operator was less than adequate.

This can apply to a number of areas in the sequence. Contributory root causes include: equipment design was poor with no human factors design for the vessel bank; supervision was poor; standards relating to design and training were poor with violations accepted as the norm. Communication among staff members was informal and unstructured.
