Geological Investigation

Bogna Hydro Power Plant

Report

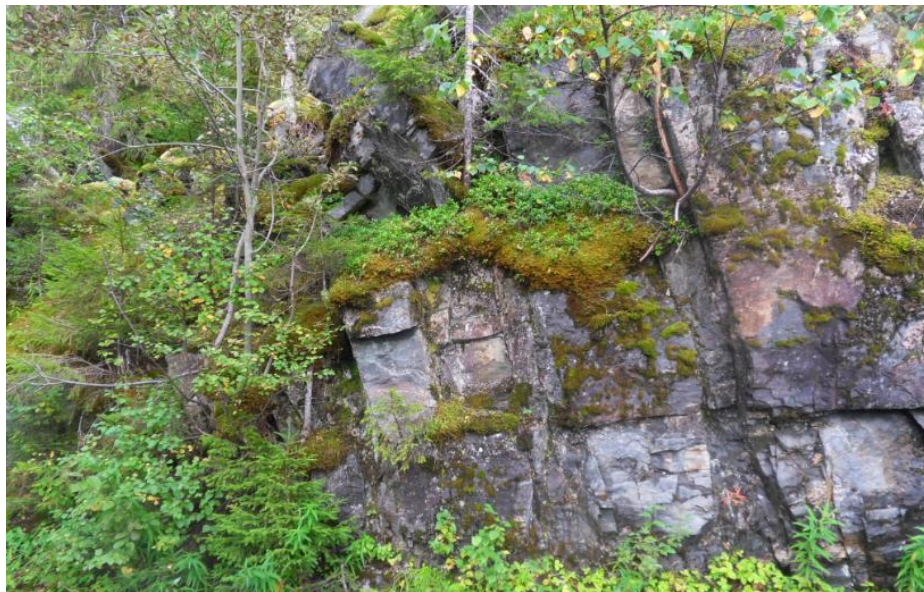
LOCATION – 1, 2 & 3

In these locations relatively massive sandstone with a very visible jointing and with no distinct bedding plane was found .Joint spacing is approximately 1m.

Fig.1.Sandstone

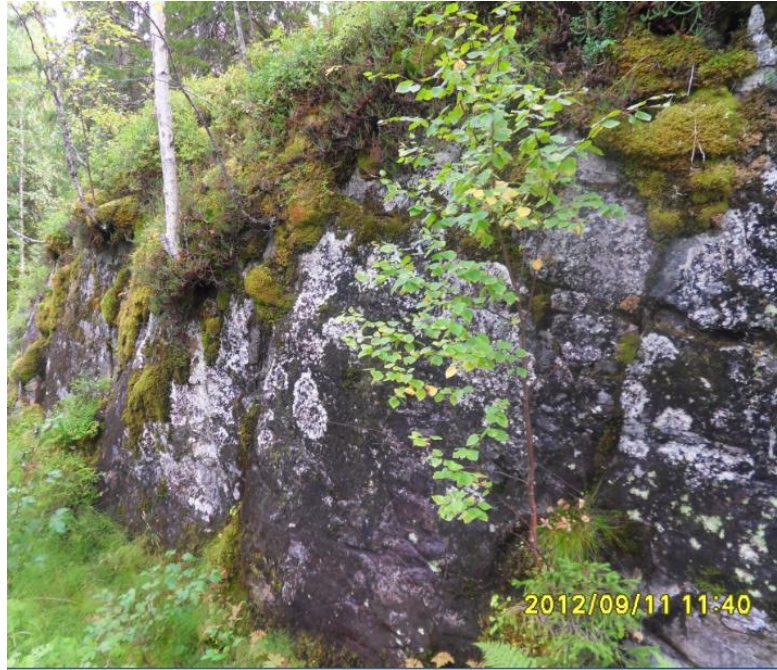
LOCATION-4, 5

A massive Green stone in between metasandstone was found (at location 4). It has no visible joint sets and no bedding plane.

Fig.2. metasandstone

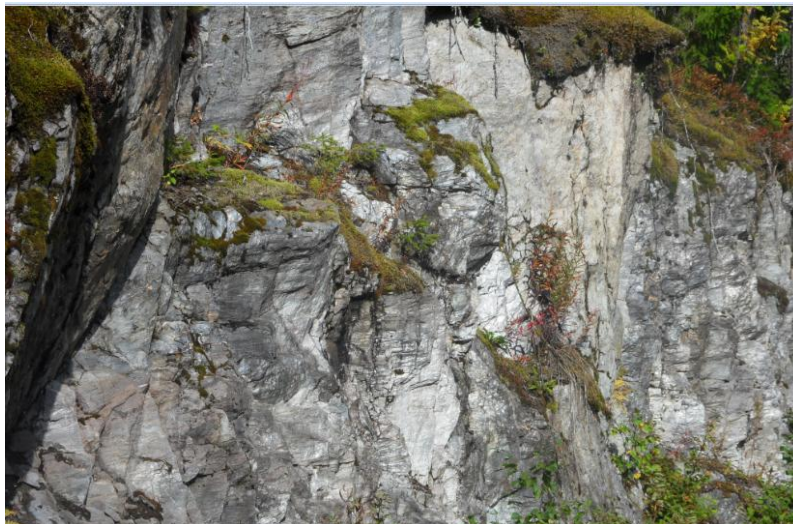
LOCATION-6

In this location sandstone (left side) and phyllite which is intensely folded and fractured was found.

Fig.3.Phyllite

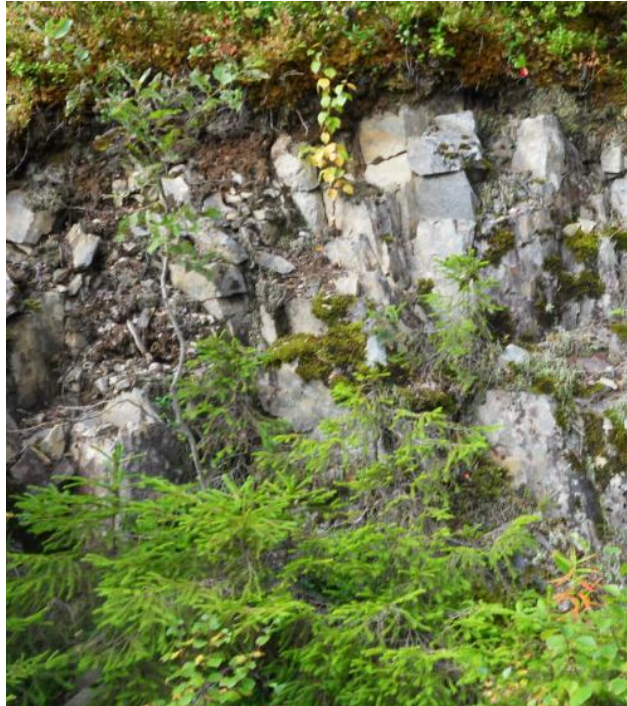
LOCATION-7

Slightly weathered metasandstone was found at this location.

Fig.4.Weathered Sandstone

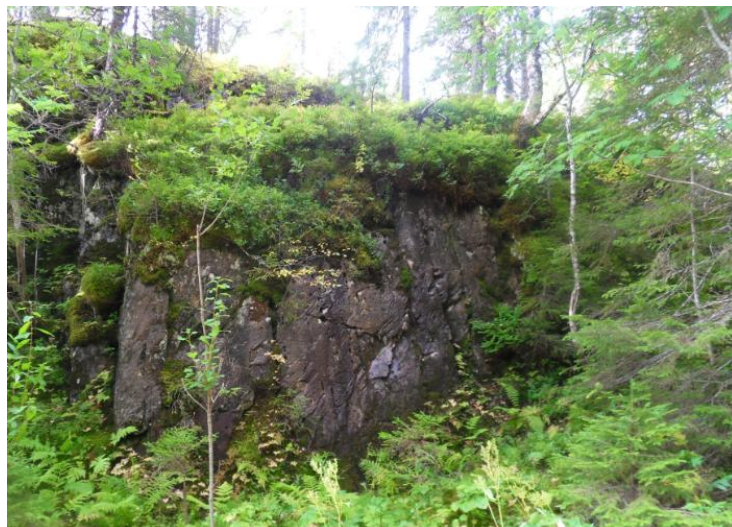
LOCATION-8, 9 & 11

It cannot be proved exactly what type of rock it is at this exact location. It is a massive very strong which look like green stone was observed.

Fig.5.Greenstone

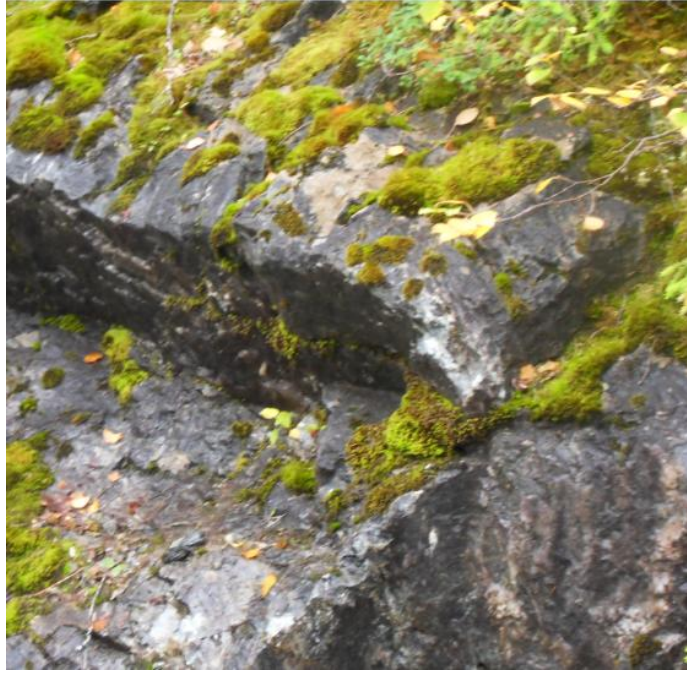
LOCATION-10

Slightly metamorphosed lime stone which is unclean .It was also found calcite containing sandstone.

Fig.6.Limestone

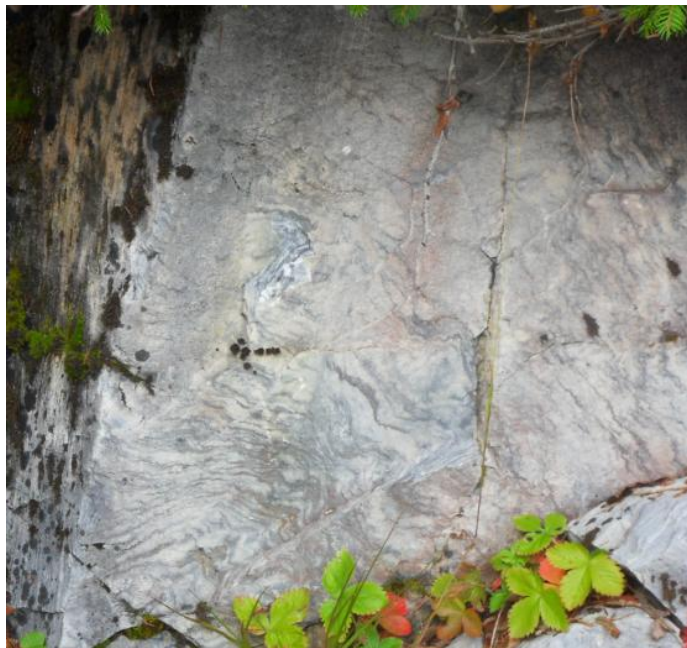
LOCATION-12 & 13

A metamorphic rock containing calcite, unclean marble or limestone with dense layers of sand. A very distinct bedding plane was observed also.

Fig.7.Unclean marble/limestone

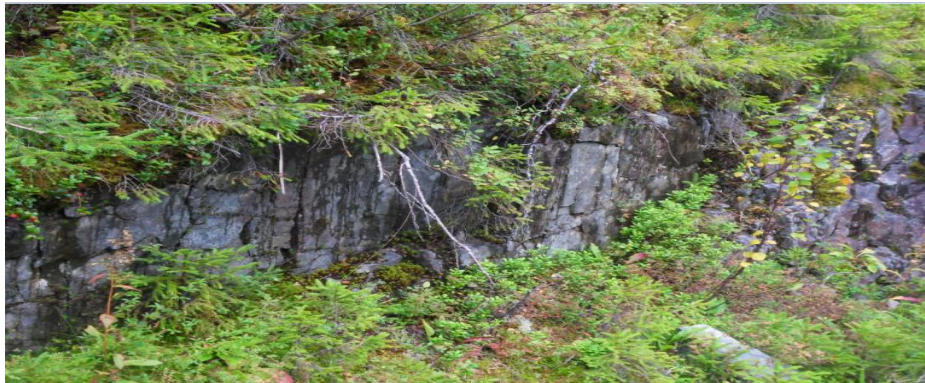
LOCATION-14

The rock type that was found in this specific location is Gneiss or calcite.

Fig.8. Gneiss

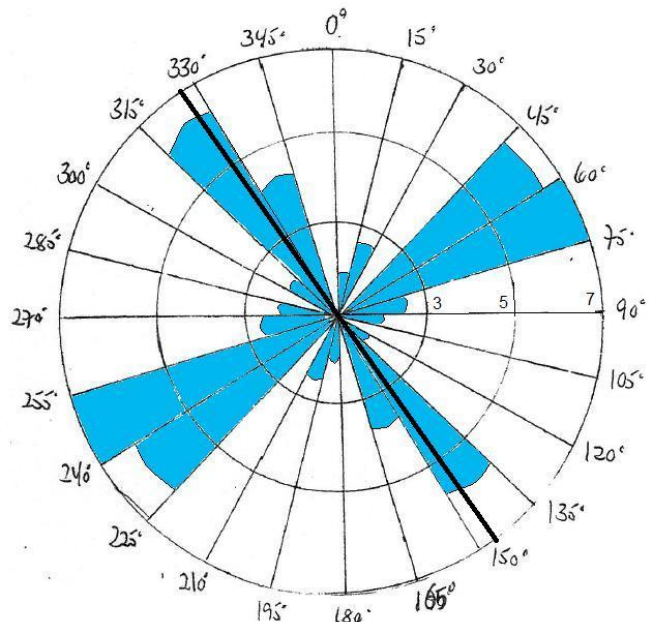
Fig.9. Joint Rosette. The black line is the tunnel alignment

As can be seen on figure 9 there are two main headings. One is from South West to North East and the other one is from North West to South East. There are also other measurements of one or two other headings but they are not major. The main directions are those two indicated in the figure above.

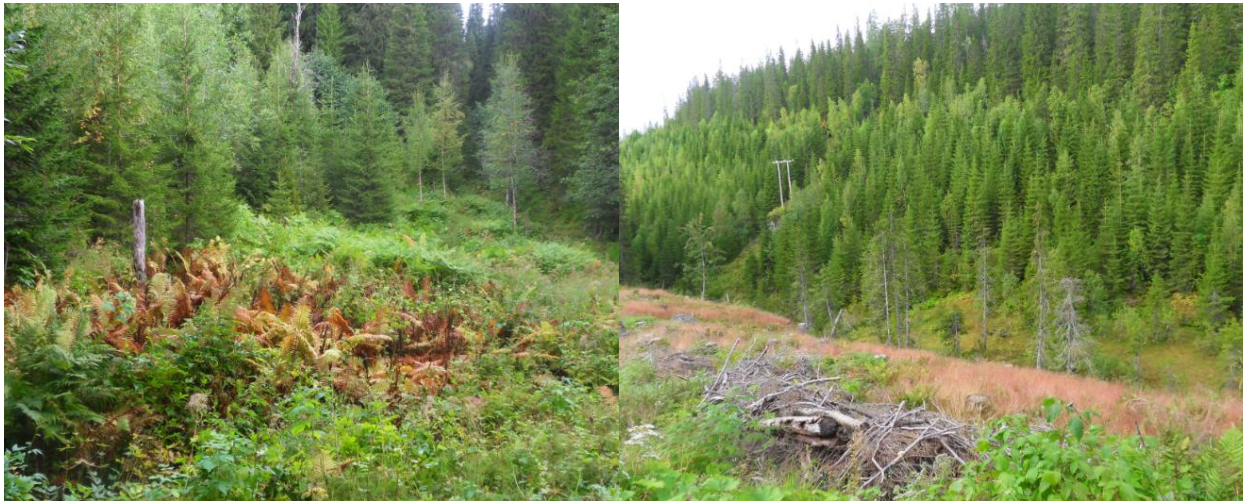
Fig.10.Weakness zone

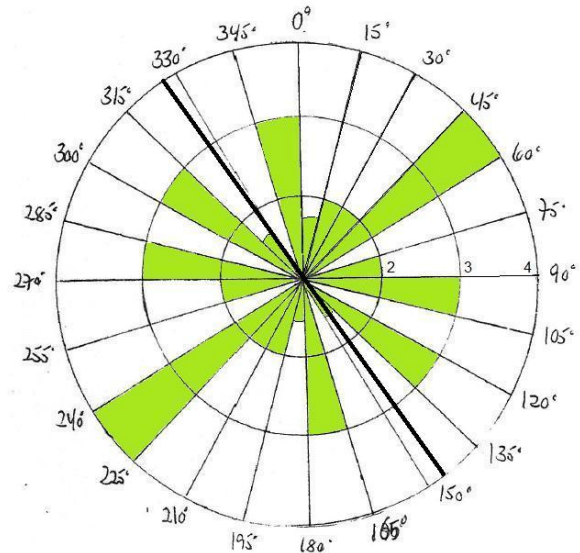
Fig.11.Joint Rosette. The black line is the tunnel alignment

As can be seen on figure 11, there is only one main heading. It is North East to South West. The other is almost equally distributed on other direction.

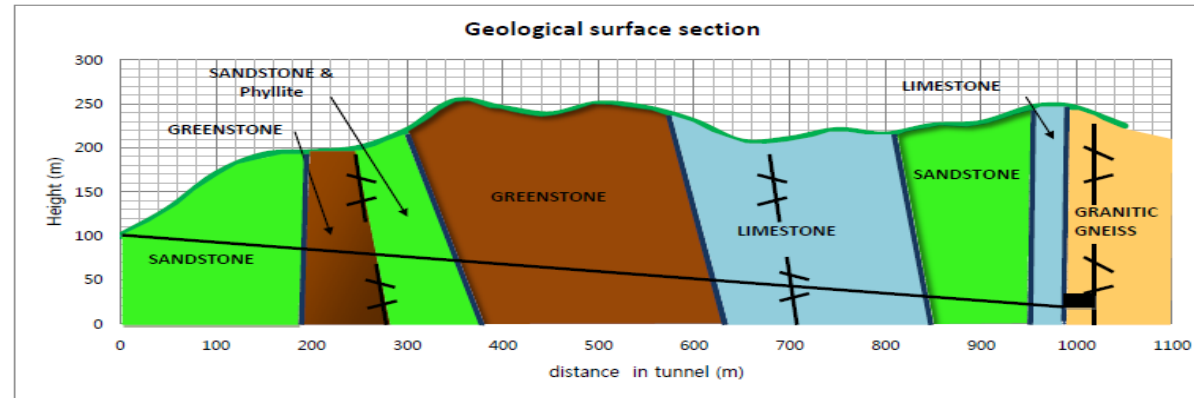
Tunnel mapping logs

In the tunnels we mapped couple of weakness zones. Mostly they were close to the bottom of the tunnels. We found weakness zones at 975 m, 740 m, 650 m and 550 m. They vary in width from about 8 m to 30 m. (For more details, see sheet from tunnel mapping in appendix)

The tunnel turned out to be almost dry. The walls on some places where wet but the leak from the walls was very small. In the ceiling there was water shielding placed a cloth so the water wouldn't drip from the ceiling to the floor. There were only two places in the tunnels where the water leakage was significant. First at about 350 m from the entrance. There we estimated that the water was dripping at a rate of about 1 L/per.minute for a section of about 50 m. The other place that we estimated the water inflow was at about 150-200 m. There we estimated that the water was dripping at a rate of 3 L/per.min. (For more details, see sheet from tunnel mapping in appendix)
