Society of Naval Architects & Marine Engineers  
Northern California Section  
Student Paper Presentation  
April 9, 1992

# The Grounding of *Exxon Valdez*: An Examination of the Human and Organizational Factors

William H. Moore, Student Member  
Department of Naval Architecture & Offshore Engineering  
University of California at Berkeley

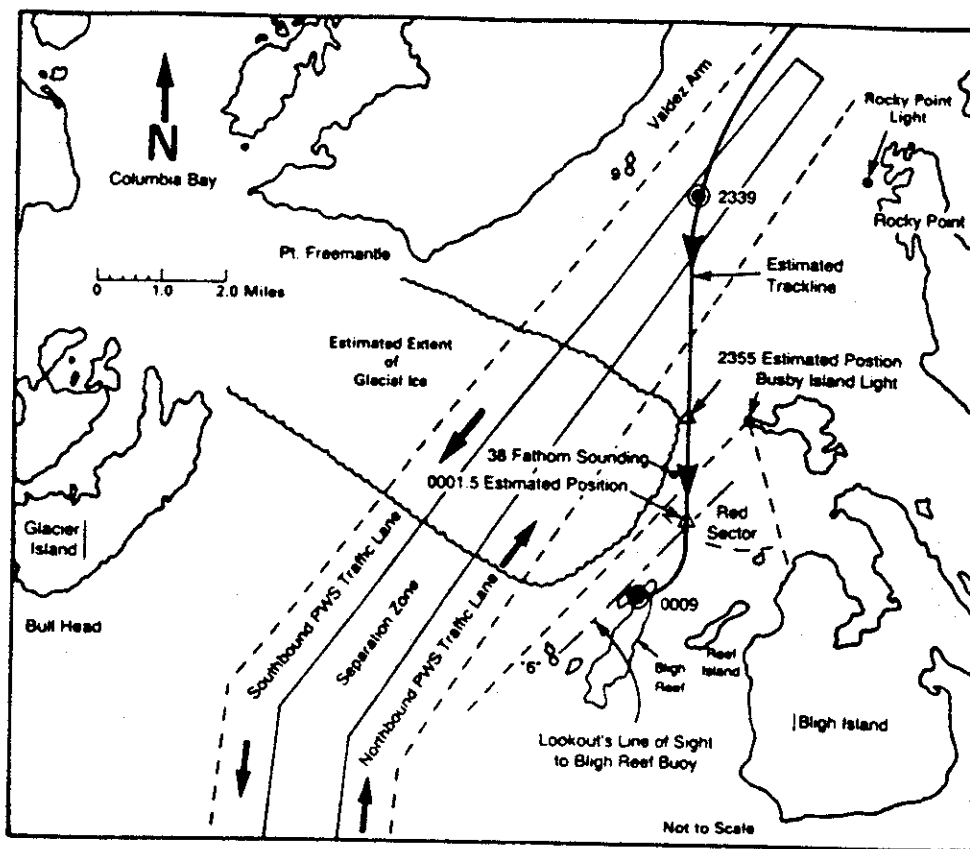
Figure 1: Trackline of *Exxon Valdez* [9]

shown in Figure 1. The ship was on "load program up" which meant she was increasing her speed while exiting the harbor. Thus, *Exxon Valdez* was traveling at 12 knots and on automatic pilot just prior to hitting Bligh Reef. Putting the ship on automatic pilot in confined waters and not telling the third mate the master had done so was extremely inconsistent with

normal practice. At his relief at 2350, the helmsman reported to the third mate that the ship was on automatic pilot, something the third mate did not know about (there is some speculation that the ship was operating on automatic pilot until the grounding). The third mate did not discuss the reason for the automatic pilot with the master.

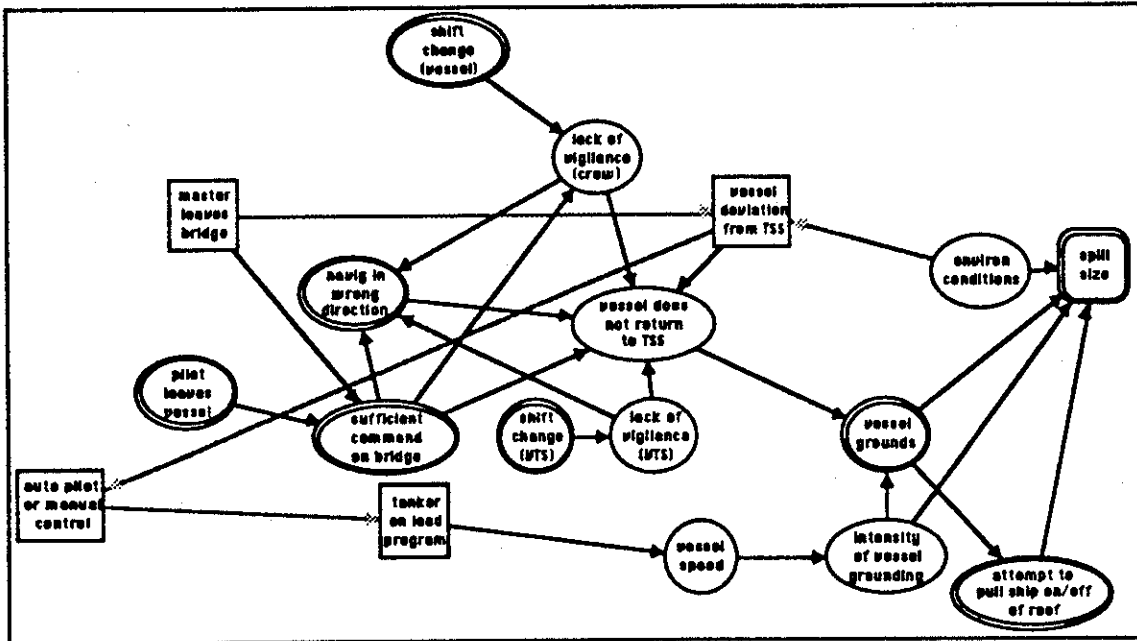
Figure 2: Influence of events and decisions leading to the grounding of *Exxon Valdez*

The model represent the set of events that occurred aboard the *Exxon Valdez*, the vessel transit in and out of the TSS, and at VTC in Valdez. Figure 2 summarizes the dependency of events, direct causes and decisions involved in the grounding discussed above. These influences are represented by nodes, (events, causes, and decisions) and arcs which establish the dependencies. Probabilities are represented by oval nodes, deterministic events are represented by double-lined oval nodes, decisions are represented by rectangular nodes, and expected returns are represented by double-lined rectangular nodes. The development of influence diagram models should be the effort of a group of experts. Discussion of differences in opinion of the relationships of between events and their causes illicit the development of more realistic models [14].

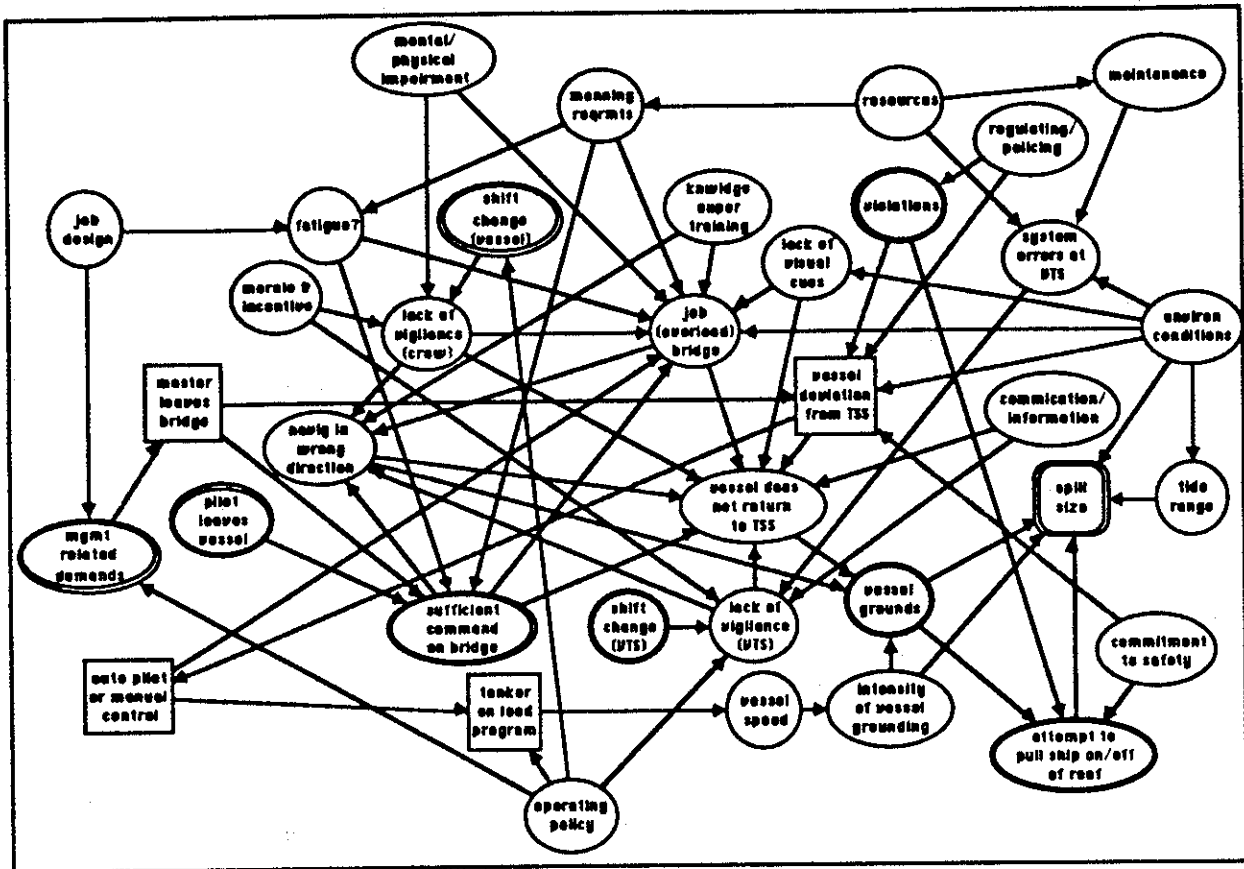
Figure 4: Influence of HOE causes on the grounding of Exxon Valdez

investigators, form the basis for the U.C. Berkeley HOE project taxonomy. The AHFT distinguishes underlying, direct, and compounding causes to marine casualty events as exemplified in Figure 3. Additional sources are used to examine *violations, commitment to safety, and resources*. The influence of causes upon the decisions and events specific to *Exxon Valdez* are shown in Figure 4.
