Official Norwegian Reports

2008: 8

The Loss of the “Bourbon Dolphin” on 12 April 2007

Report from a Commission appointed by Royal Decree of 27 April 2007.
Submitted to the Royal Norwegian Ministry of Justice and the Police on 28 March 2008.

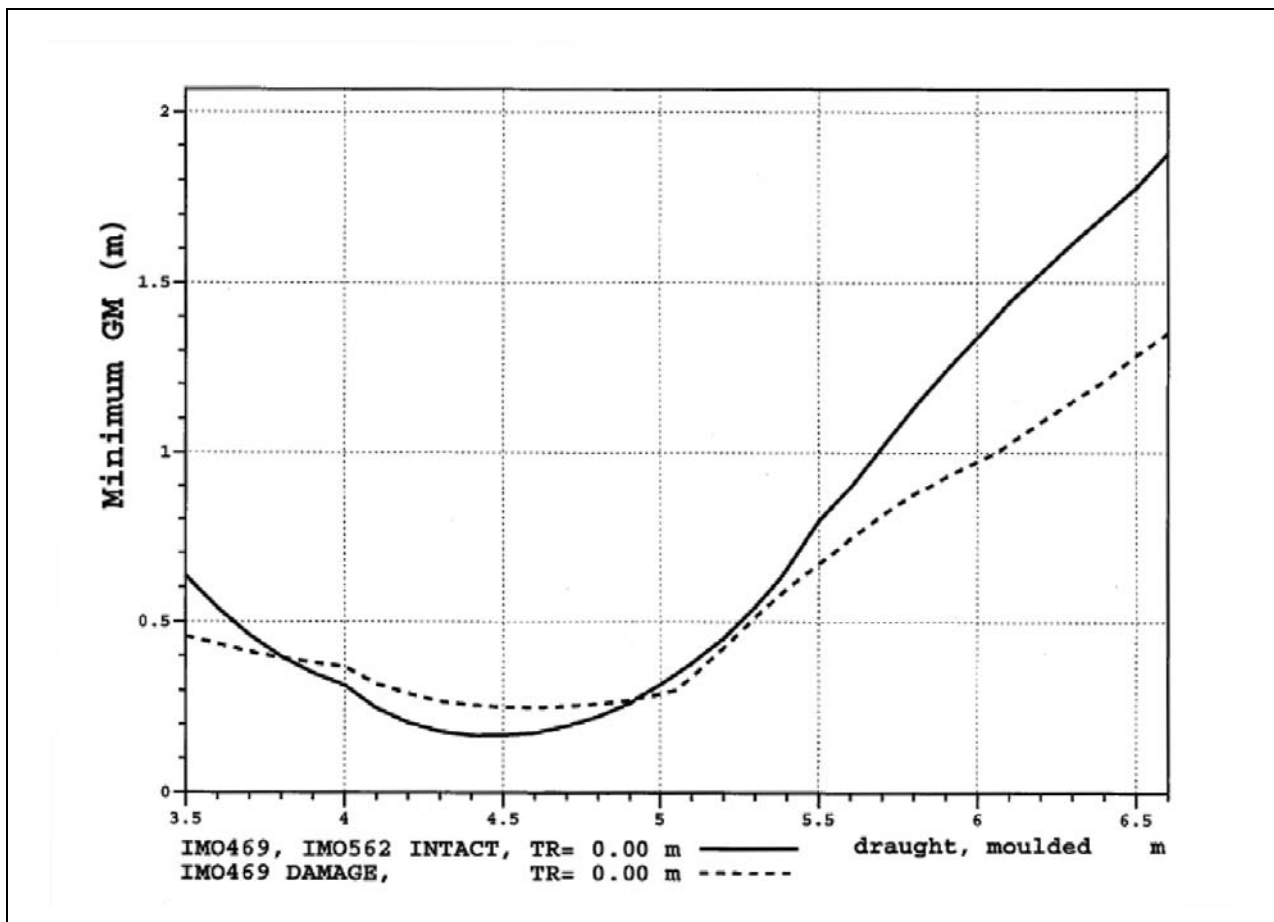
Figure 5.4 GM min curve

Curves are created for a set of trim values. The vessel's GMmin curves (one for intact and one for damaged stability) for trim = 0.0 m are shown in Figure 5.4.

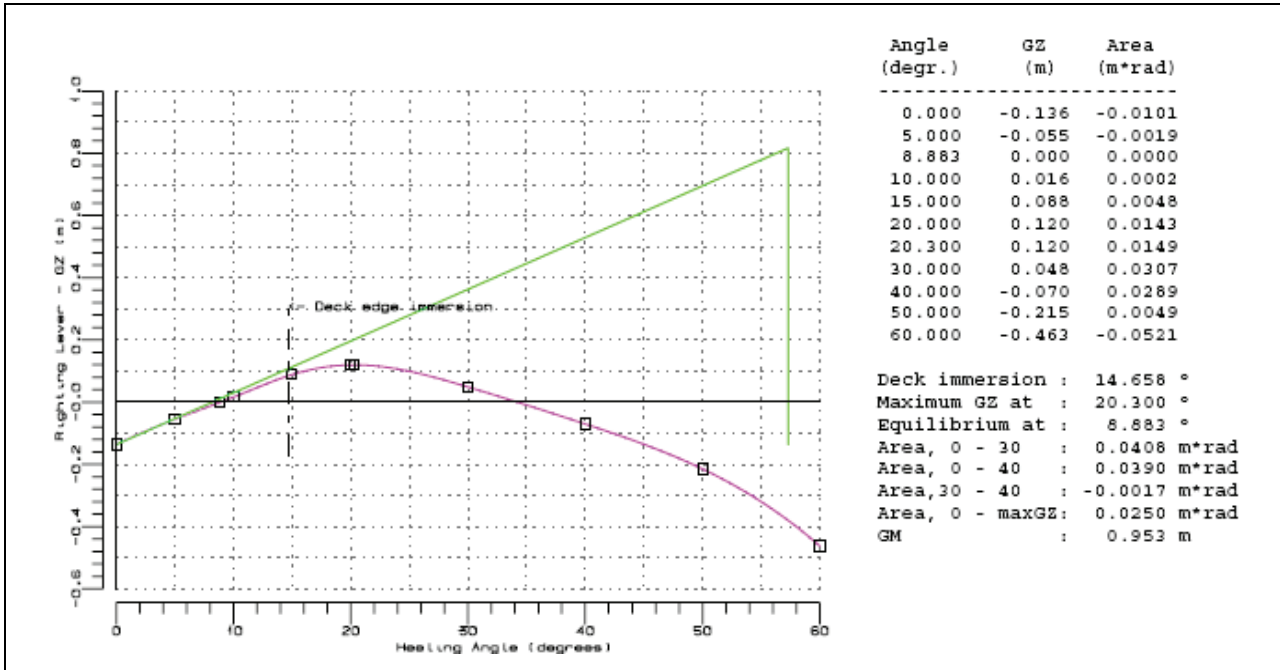
Figure 9.14 Correcting and heeling arms for load condition 3.1 after towing-pin is depressed. 40% angle of attack, 126 tonnes tension

In this situation the vessel has some stability left with a positive reach of the GZ curve to 34°. This is in a situation in which the vessel is stressed with a mean tension. When the pin is depressed the vessel, in consequence of the dynamic conditions, may acquire a list angle of 15 to 20° before she rights herself and acquires a permanent list angle of 7-9°, depending on the anchor-line's angle of attack. For example an angle of attack of 40° gives a permanent list for this condition of about 9°. See Figure 9.14, also Annex 1, Section 1.12 (pages 10-15) for more details.

According to witness observations, the vessel first acquired a powerful list to port, and thereafter quickly more or less righted herself again. The calculations for this load condition correspond to these observations. According to the calculations shown in Figure 9.14, the vessel has a positive GZ curve up to a list angle of about 34° and will therefore right herself from a relatively large list angle.

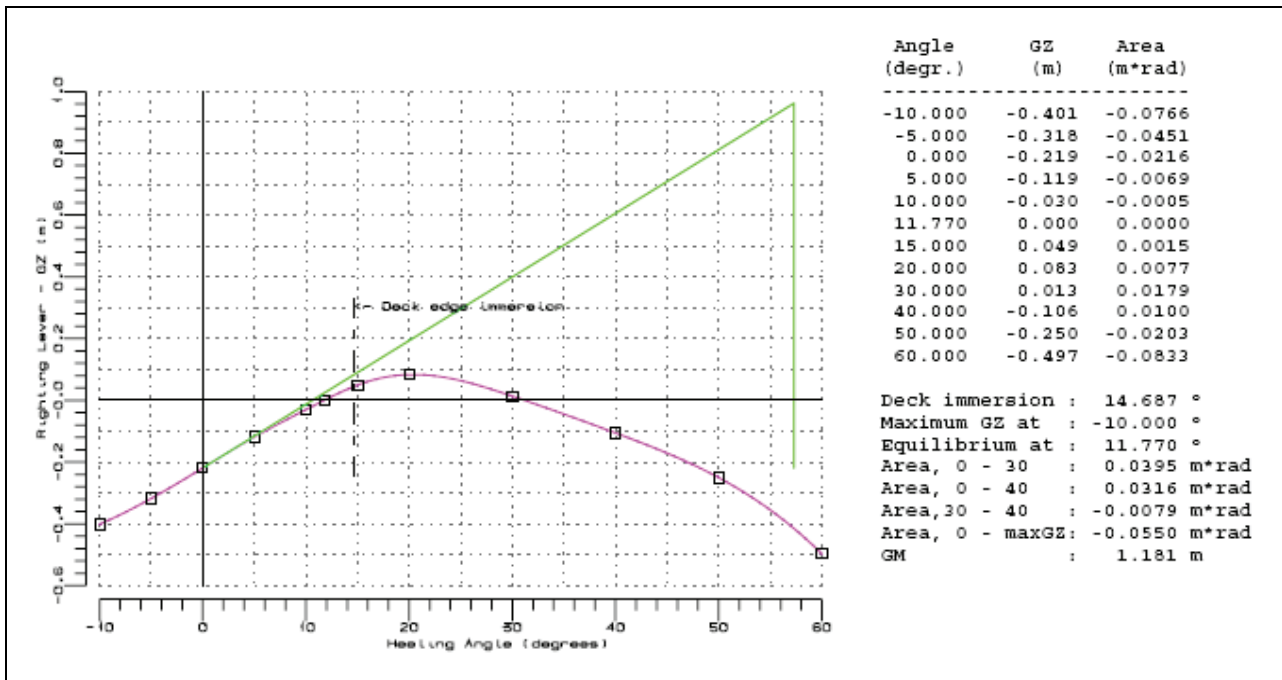
Figure 9.15 Correcting and heeling arms for load condition 3.1 after towing-pin is depressed, 60° angle of attack, 180 tonnes tension

Mooring line's angle of attack (°)	Horizontal transverse force (tonnes)	Vessel's list angle (°)
20	37.9	8.9
25	46.8	9.7
30	55.4	10.5
35	63.6	11.1
40	71.2	11.7
45	78.4	12.3
50	84.9	12.9
55	90.8	13.4
60	96.0	13.9

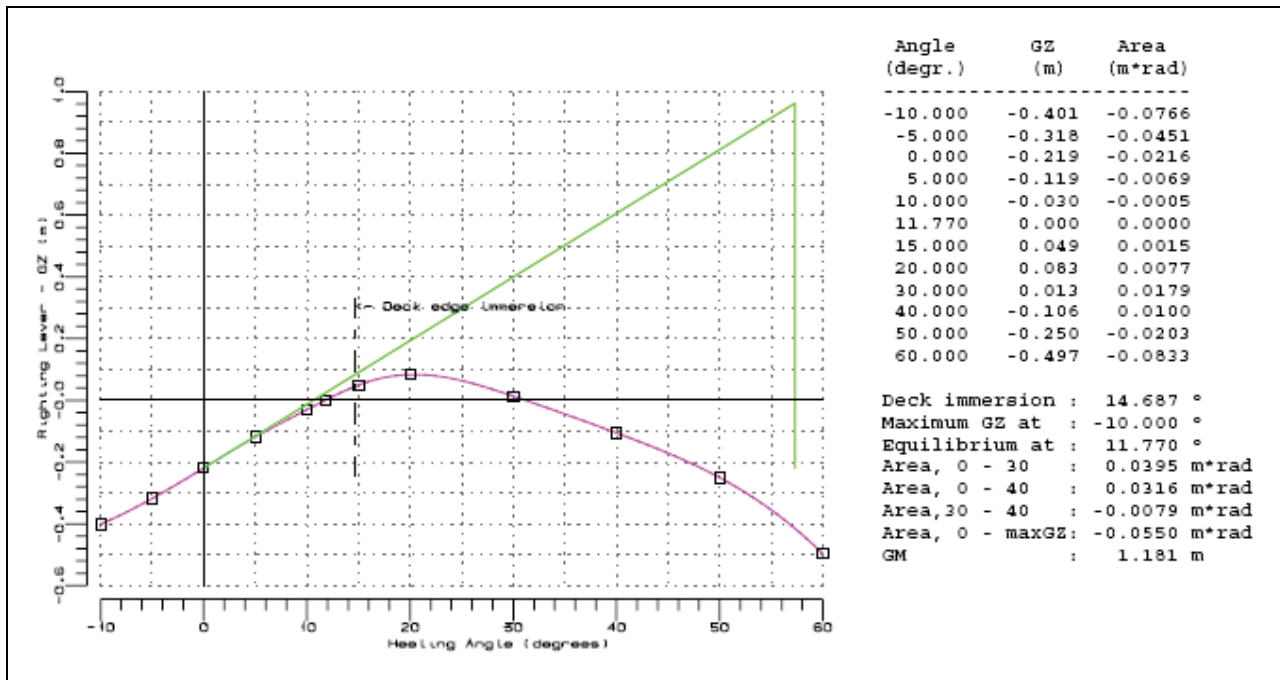
Figure 9.16 Correcting and heeling arms for load condition 3.2 after towing-pin is depressed, 60% angle of attack, 180 tonnes tension

ve for this situation is shown in Figure 9.16. See also Annex 1, Section 1.12 (pages 21-25). This GZ curve means that the vessel should have sufficient stability to tolerate the maximum tension of 180 tonnes even with an angle of attack of 60°, taking into account that the vessel is lying with a permanent list angle of 5-7° with mean chain tension.

“trapped” on deck for a short period and in a similar way compromise the vessel’s stability.
