Official Norwegian Reports

2008: 8

The Loss of the “Bourbon Dolphin” on 12 April 2007

Report from a Commission appointed by Royal Decree of 27 April 2007.
Submitted to the Royal Norwegian Ministry of Justice and the Police on 28 March 2008.

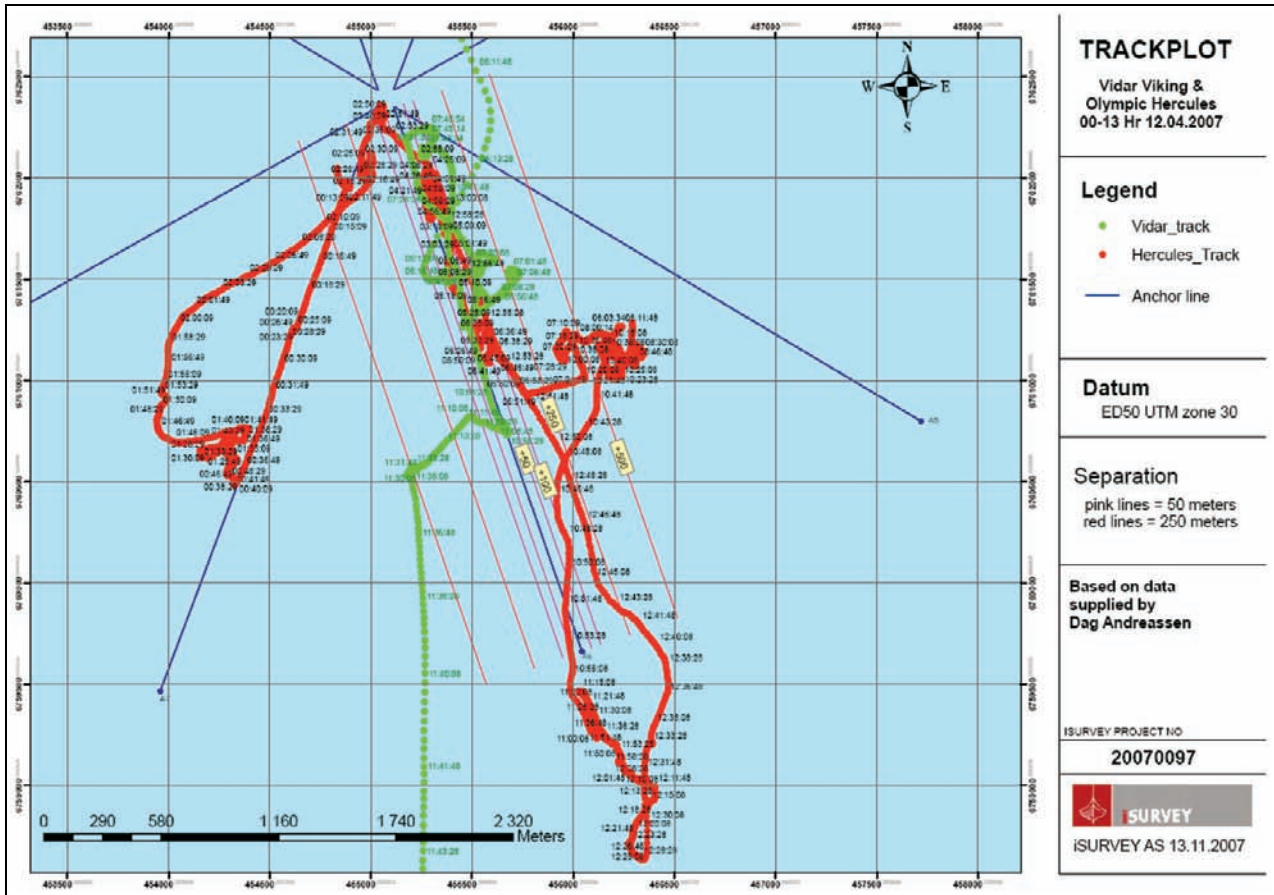
Figure 9.1 Trackplot for deployment of anchor no. 6

The “Olympic Hercules” did not manage to get back on track using her thrusters and rudder/propeller alone. At the worst, the “Olympic Hercules” had drifted about 730 metres east of line no. 6. According to Captain Grim Bergtun, the current was normally 2.5 knots, but that day was stronger.

The rig first asked the “Olympic Hercules” to wait, while the “Bourbon Dolphin” deployed anchor no. 2 together with the “Highland Valour”. The “Olympic Hercules” used her lateral thrusters on full (80 %), but was still drifting off, and so Captain Bergtun did not want to heave to and wait. Bergtun asked the rig to pay out its wire so as to give the “Olympic Hercules” speed for manoeuvring. The towmaster at first refused, but later granted the request, and wire was paid out from the rig’s winch.

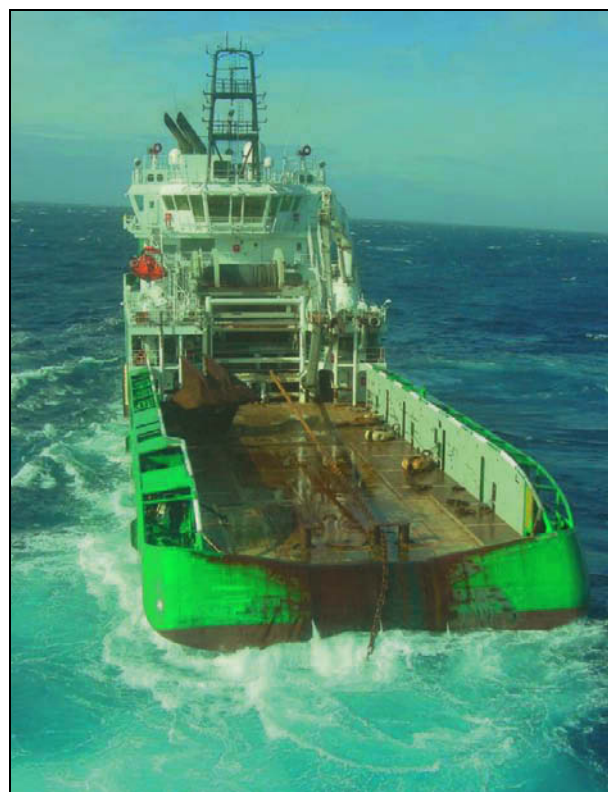
Figure 9.3 The “Bourbon Dolphin” at 16:31

12 April there remained the deployment of the last secondary anchor, anchor no. 2. This was a 18-tonne Bruce anchor, which the “Bourbon Dolphin” had taken on board in Lerwick on 9 April. The anchor was on deck, lashed to the cargo rail on port side, as shown in Figure 9.3.

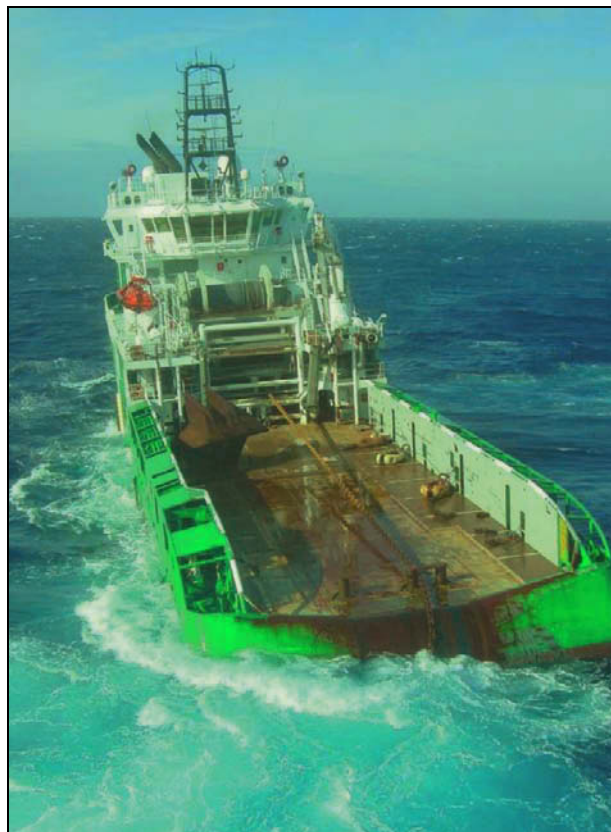
Figure 9.6 Picture taken at 16:31.

- Vertical:
 - 8.17 m over the vessel's baseline (top of the stern roller)
- Transversely:
 - 0.6 m to starboard when the chain is between the starboard towing-pins. In this situation the chain has an angle of attack to port and may easily be seen in figure 9.6.

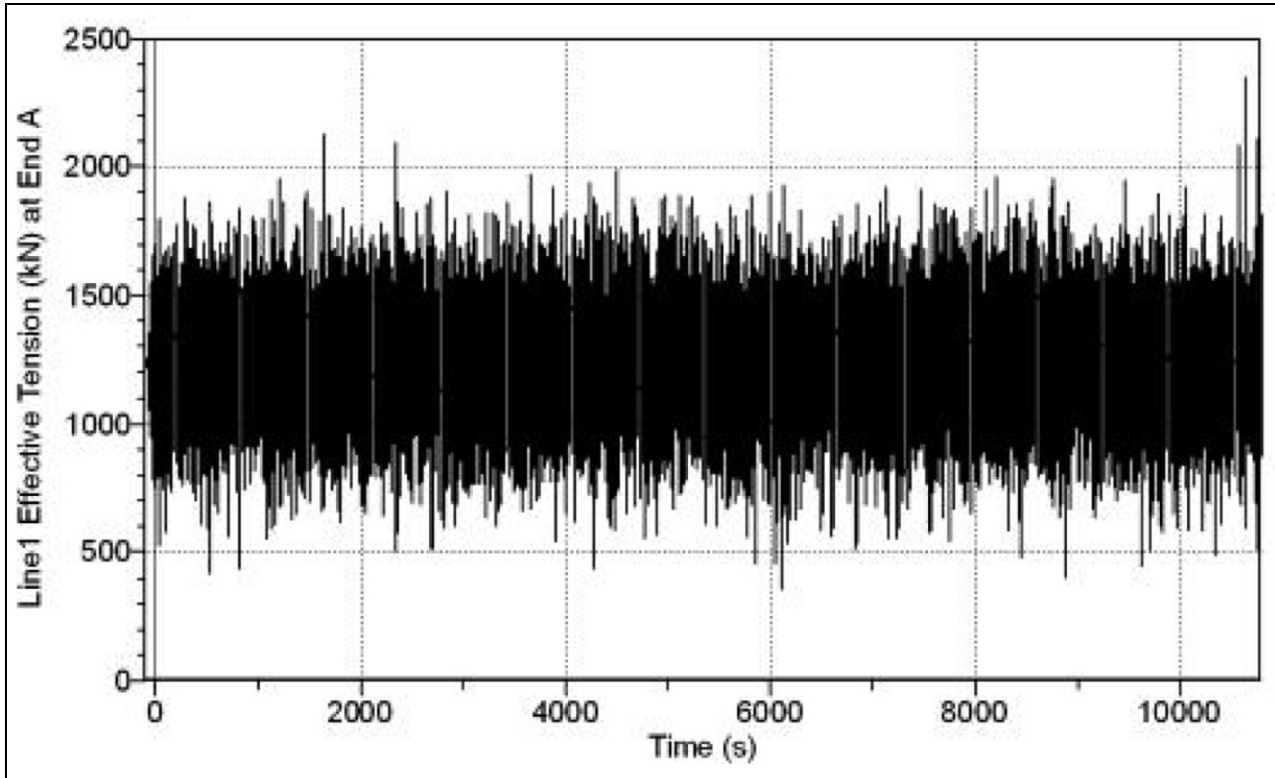
Figure 9.8 Line loads

The analyses show that there is a mean force of 126 tonnes with a standard deviation of 22 tonnes, see Figure 9.8. The vertical component of this force is 100 tonnes and the horizontal component 78 tonnes. The tensions in the simulation vary between 35 and 240 tonnes. As seen in Figure 9.8, the forces vary between 80 and 180 tonnes most of the time. The tension variation has a period corresponding to the waves, confer Section 9.5. This is in conformity with observations made by First Officer Syversen, who stated that he could read tension off the winch as 80 and 180 tonnes during the deployment of anchor no. 2.

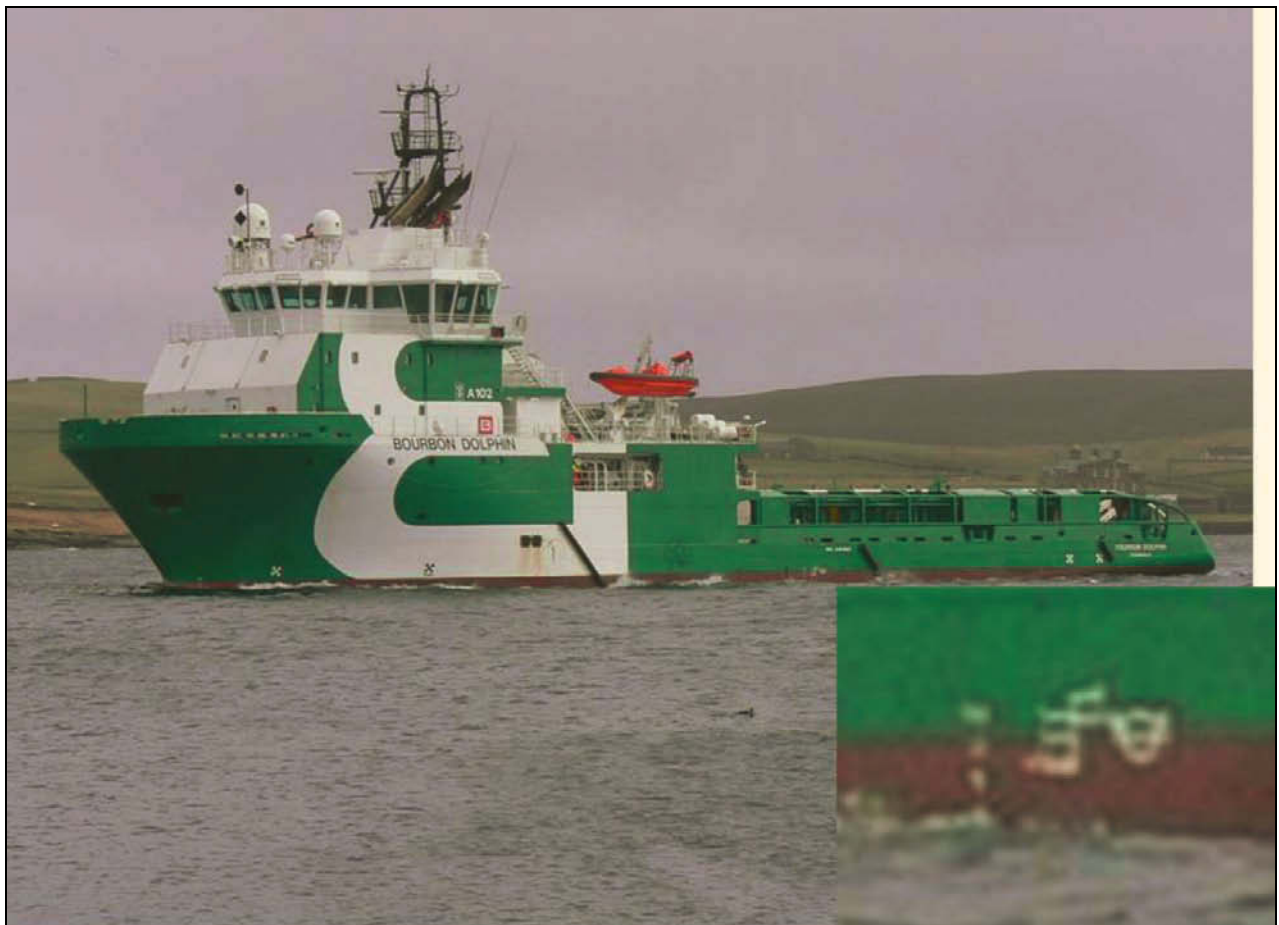
Figure 9.11 Bourbon Dolphin on arrival at Lerwick at 14:35 on 10 April

The vessel was photographed on arrival at Lerwick (see Figure 9.11). From this picture it may
